SLAB REPLACEMENT GUIDELINES

STATE OF CALIFORNIA
DEPARTMENT of TRANSPORTATION

January 2004

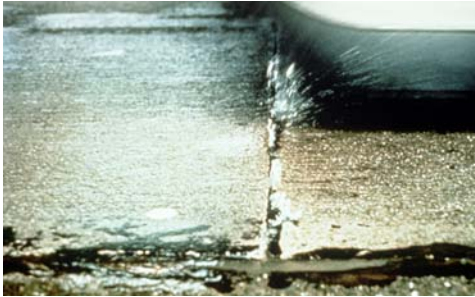
Pumping in action

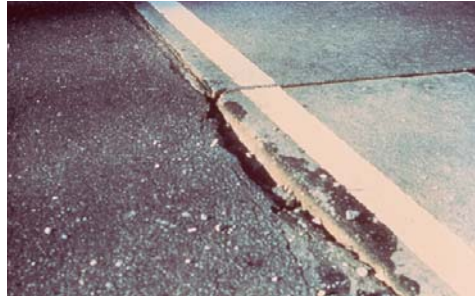
Loss of shoulder material due to pumping

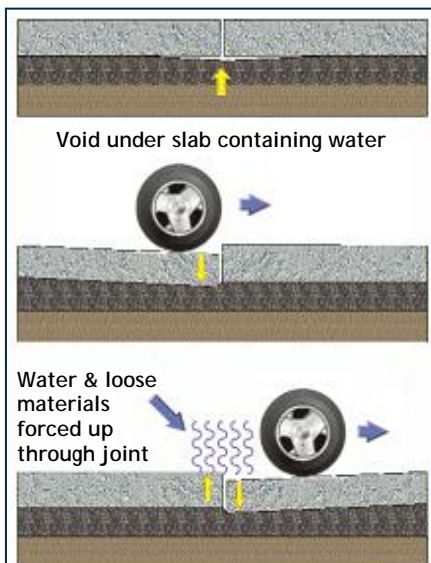
Pumping schematic

Pumping is the ejection of loose materials carried by water from under the pavement through cracks and joints when impacted by traffic.

Four conditions must coexist for pumping to occur: frequent heavy axle loads, poor joint LTE, erodible base and/or wet-fine subgrade, and the presence of excess water under the pavement.

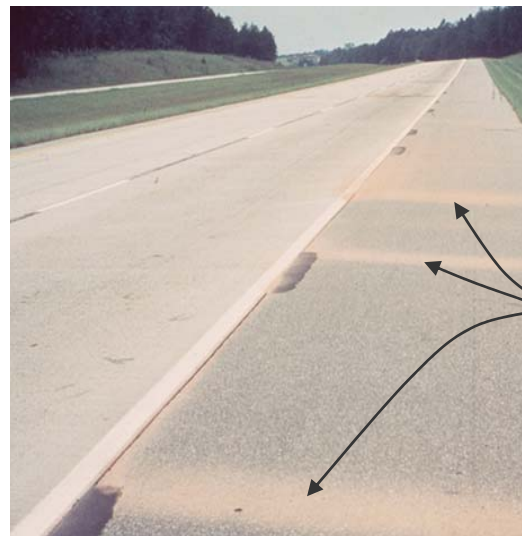
Pumping of loose pavement fines onto the highway shoulder

- Pumping can also cause transverse cracking, spalling of the joints, and faulting, and it may contribute to longitudinal cracking.
- Fines from pumping and erosion of the base and subgrade can be seen along shoulders, especially after a rainstorm, as shown on page 5.

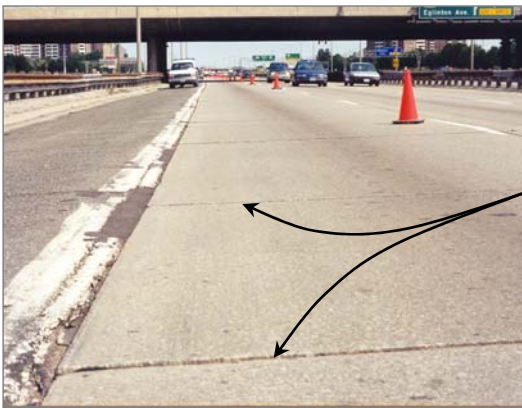
Faulted joints

Faulting is a difference in elevation between slabs at joints or cracks.

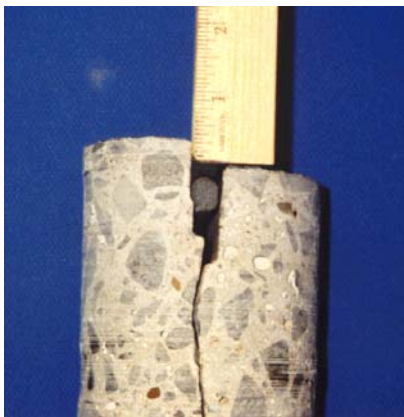
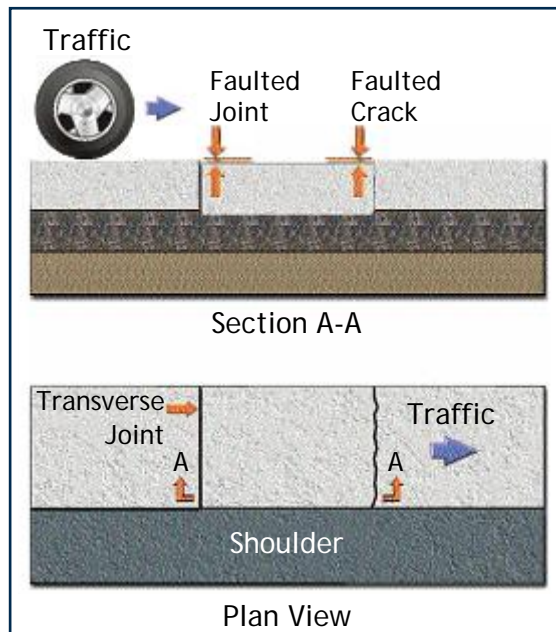
Faulting schematic

- Faulting is caused by a combination of heavy axle loads, poor joint or crack load transfer efficiency, erodible material in the layers beneath the concrete slab, and the presence of free water beneath the pavement.
- Temperature and moisture gradients can curl the slab corners upward, resulting in increased potential for pumping and faulting.
- The hydraulic action drives the fines beneath the pavement slab in the direction opposite the direction of traffic. Over time, this results in a buildup of fines under the approach side of the joint. The amount of buildup coincides with the amount of faulting (step-off) on the pavement surface.

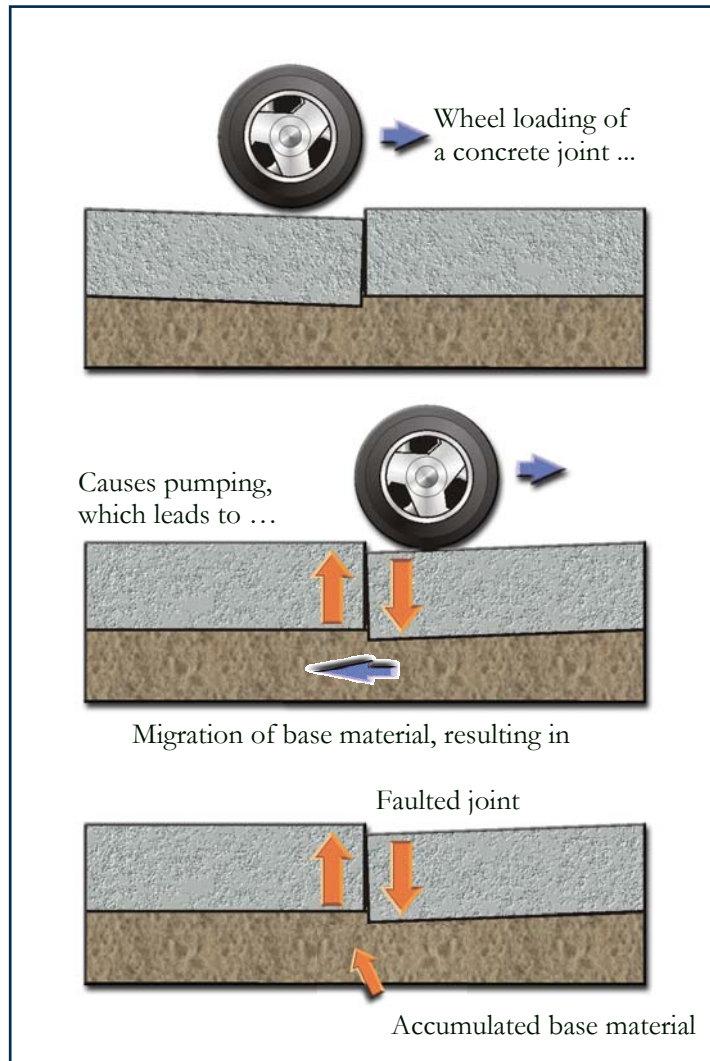
Faulting
mechanism

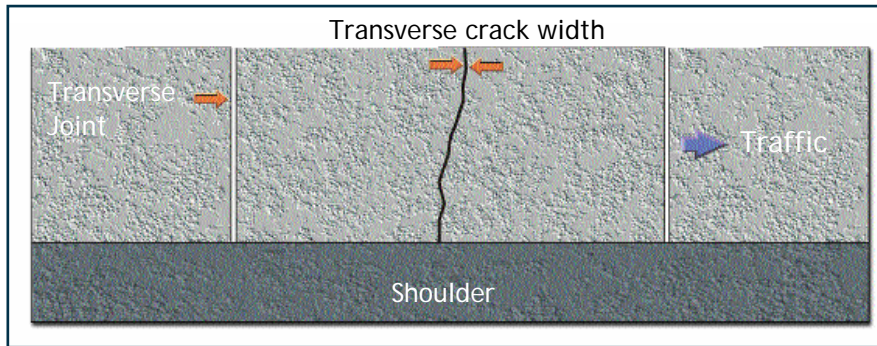
Transverse crack schematic

Transverse cracks cross the slab in a direction nearly perpendicular to the pavement centerline and the direction of traffic.

- Typically, new concrete slabs crack when tensile stresses within the slab exceed the slab's tensile strength. Early-age cracking may occur from a combination of restraining forces due to temperature changes, shrinkage, thermal curling, and moisture warping, combined with traffic loads imposed on the concrete before it has gained sufficient strength. This type of cracking can be controlled by sawing the pavement to create weakened-plane joints at appropriate intervals. Uncontrolled (volunteer) transverse cracks typically result from improper joint sawing (shallow sawed depth or late sawing).

- Transverse cracks that occur in the years following construction are primarily the result of fatigue of the concrete slab caused by repeated heavy axle loads and temperature curling. The cracks develop when the accumulated fatigue damage approaches or exceeds the fatigue life of the PCC.

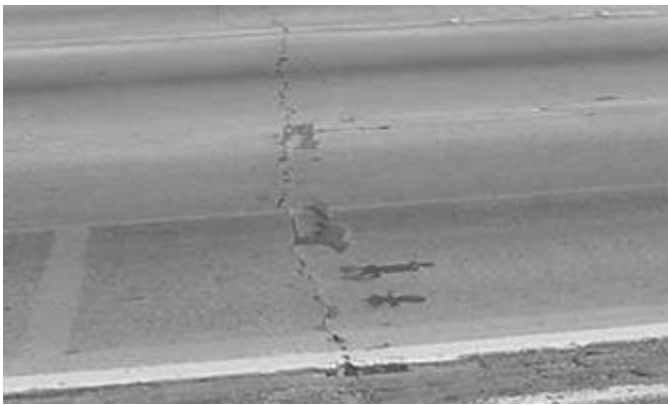
Transverse cracking

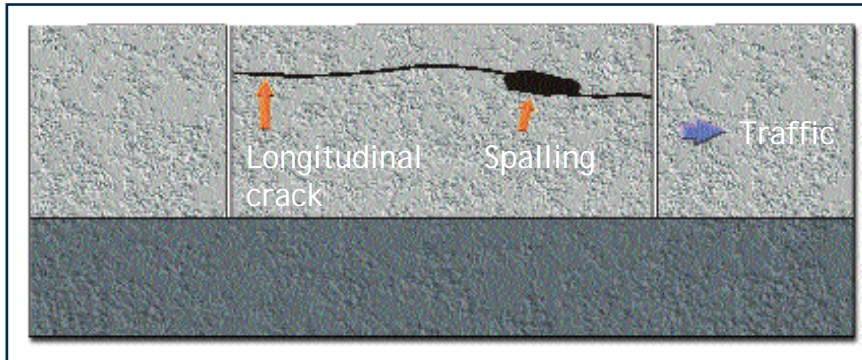
Longitudinal crack schematic

Longitudinal cracks run parallel to the edge of the slab and in the direction of traffic.

- Early longitudinal cracks can be caused by inadequate saw-cut depth or late sawing of longitudinal joints. Unless the joints form properly, the risk of longitudinal cracking is very high due to the restraining forces from shrinkage or temperature changes and stresses from slab curling and warping. Early cracking can also result from opening the pavement to traffic before the concrete has achieved adequate strength.
- Longitudinal cracking occurring late in the pavement's life may be caused by a combination of upward slab curling (temperature and moisture gradients) and heavy repeated axle loadings.

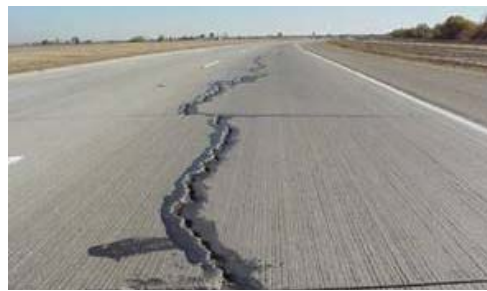
Longitudinal cracking

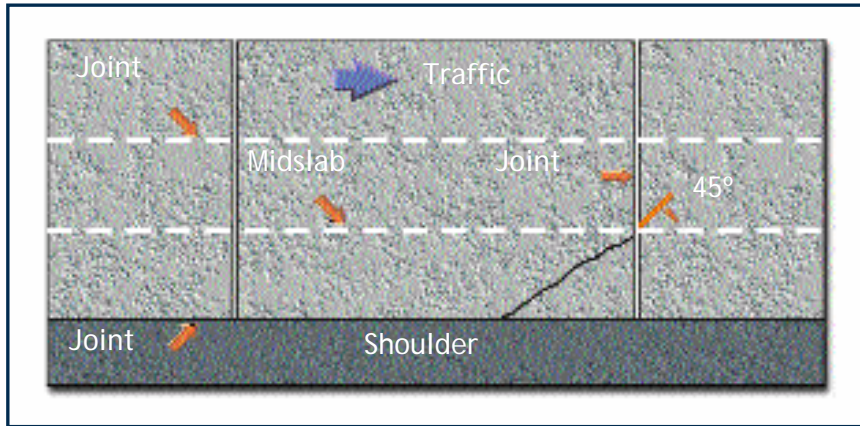
Corner breaks schematic

A corner break is a crack that intersects a transverse joint and the pavement edge at a distance of about 2 m or less on each side from the corner of the slab and is over 0.5 m long.

- Corner breaks are caused by heavy repeated axle loadings on upward curled slab corners due to temperature and moisture gradients, and lack of adequate load transfer.
- Loss of slab support (voids) due to pumping.

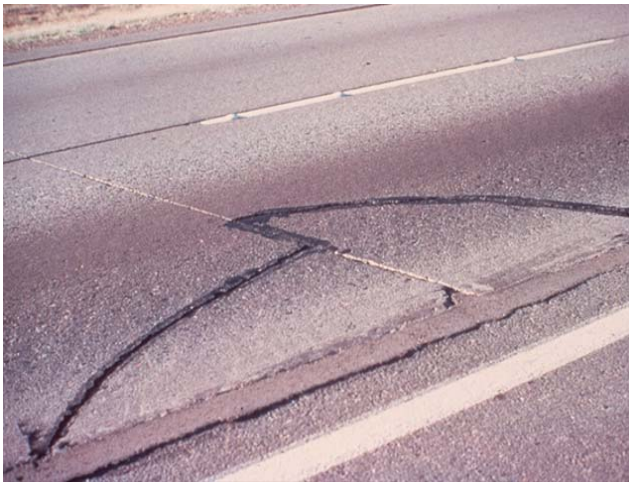
Corner breaks

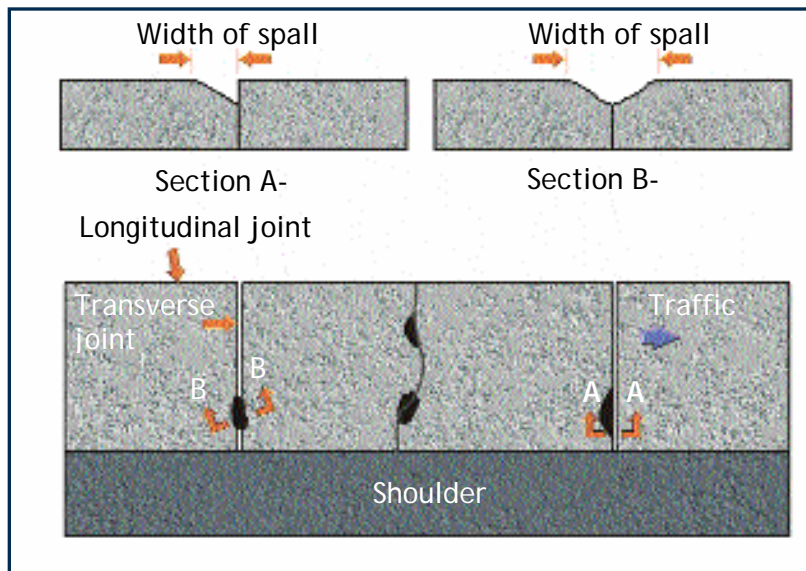
Joint spalling schematic

Joint spalling can occur at both the transverse and longitudinal joints. Medium- and high-severity spalling require full-depth repairs, unless the deterioration is limited to the upper 1/3 of the slab, in which case partial-depth spall repairs may be feasible. On a typical joint, coring can help determine the general extent of the subsurface deterioration beneath the joint.

- Spalling is caused by the build-up of incompressible materials in the joints, which causes large stresses when the slab expands. As the face of

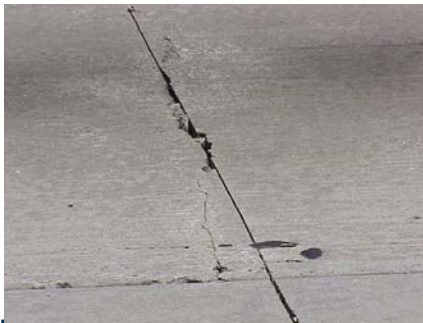
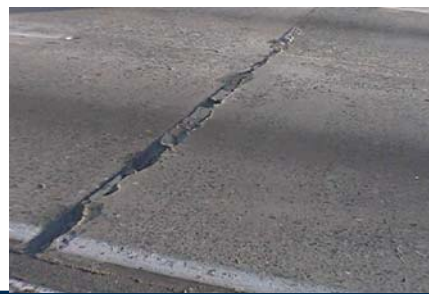
High-severity joint spalling

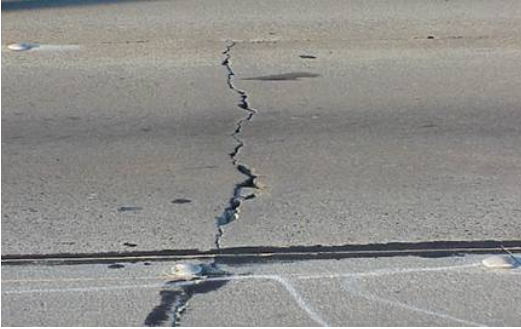
First-stage cracking

- **First-stage cracking:** Non-intersecting transverse, longitudinal, or diagonal cracks in a slab that divide the slab into two or three large pieces. This does not include corner breaks.

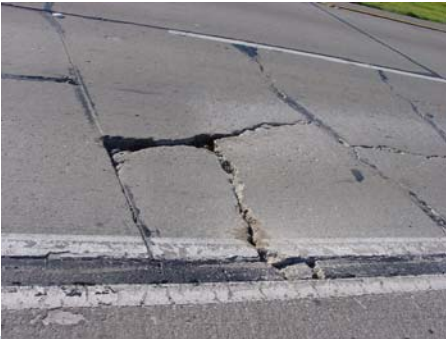
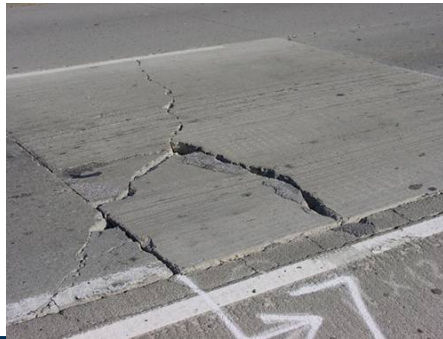
Third-stage cracking

- **Third-stage cracking:** Cracking of the slab into three or more pieces with interconnected cracks developing between cracks or joints.

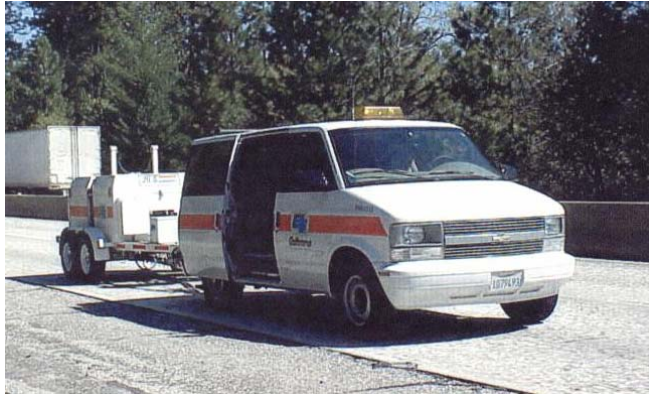
Falling Weight Deflectometer (FWD)

By collecting deflection measurements at several offsets from the load plate, the deflection profile (or basin) can be determined. In general, weak pavements have high deflections that are confined to a small area, and stiff (strong) pavements have small deflections that are distributed over a much wider area. By analyzing the magnitude and shape of the deflection basin at the slab center, the strength of the in-place pavement and subgrade materials can be estimated. In addition, the load transfer efficiency at joints and cracks, as well as the presence of voids at corners, can be evaluated quickly.

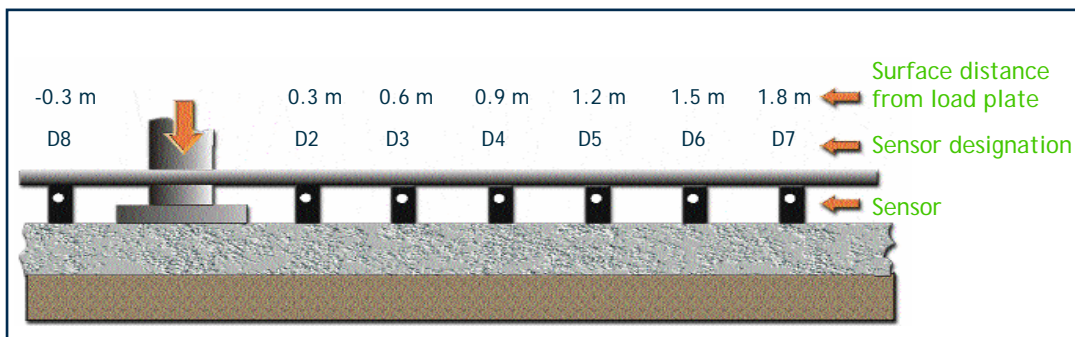
Typical FWD load plate & sensor spacing

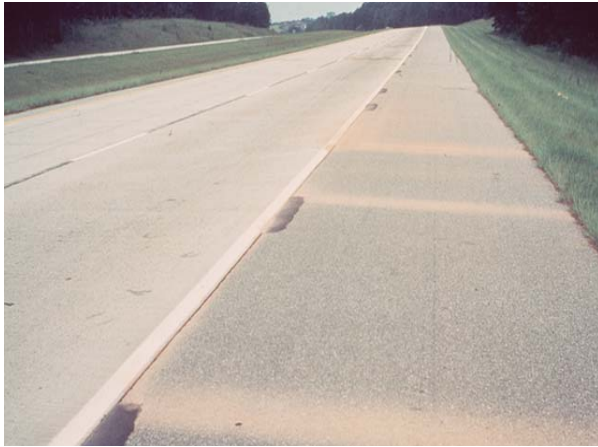
Pumping of
pavement
materials

Fines shown on shoulder of base
material pumped to surface indicates
possible voids under pavement

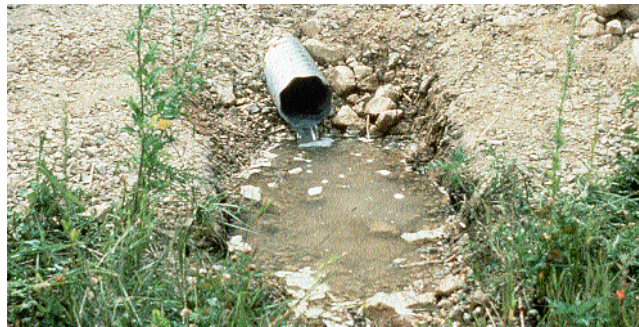
Properly
functioning
pavement
edge drain

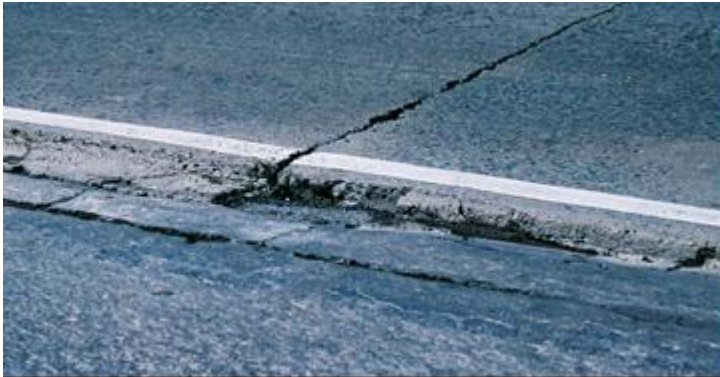
Erosion & settlement of the shoulder material

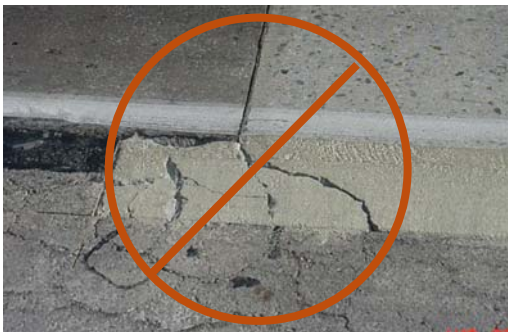
Distressed PCC patch due to construction of the patch wider than the paving lane

- Replace the edgedrain, in kind, and backfill with AC.
- Never construct a replacement slab wider than the paving lane.

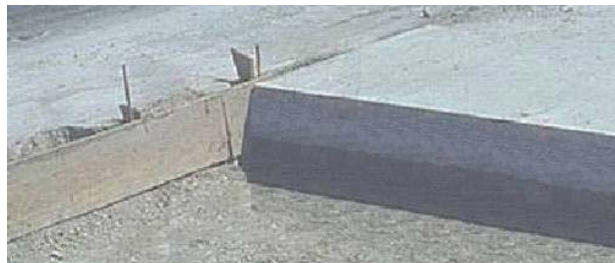
Edge form placed after removing 0.3 m of deteriorated shoulder

When the shoulder is severely distressed or settled, be sure to include detail and funding to remove 0.3 m of shoulder and place a form for the edge of pavement. The form will also be used to set a smooth grade. The gap must be backfilled with AC to match the adjacent shoulder.

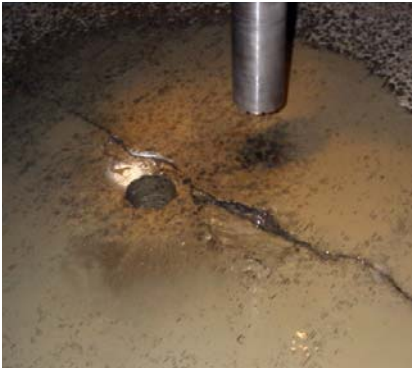
Core drilling

Limited coring may be needed to determine the extent and severity of distress beneath the pavement surface. Coring should only be used on a limited basis because it is time-consuming and causes additional lane closures. Work with your District Materials Engineer (DME) to obtain the cores. Cores will give you information about the condition and thickness of the existing concrete pavement, treated base layer, and subbase, which may indicate whether the base will need to be removed and replaced with the slab.

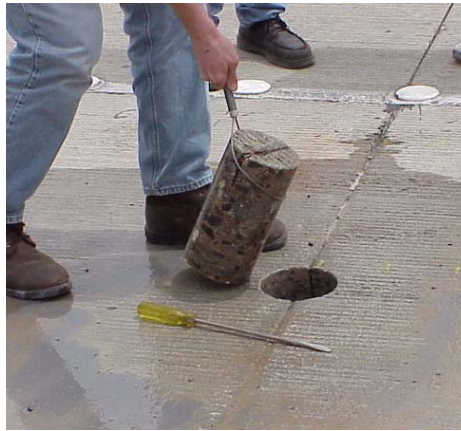
Coring to investigate the causes of pavement distress

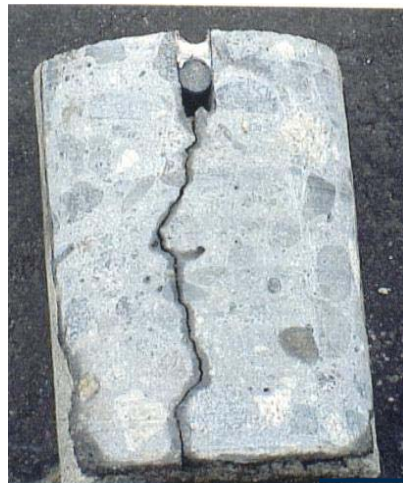
Core with backer rod and aggregate interlock

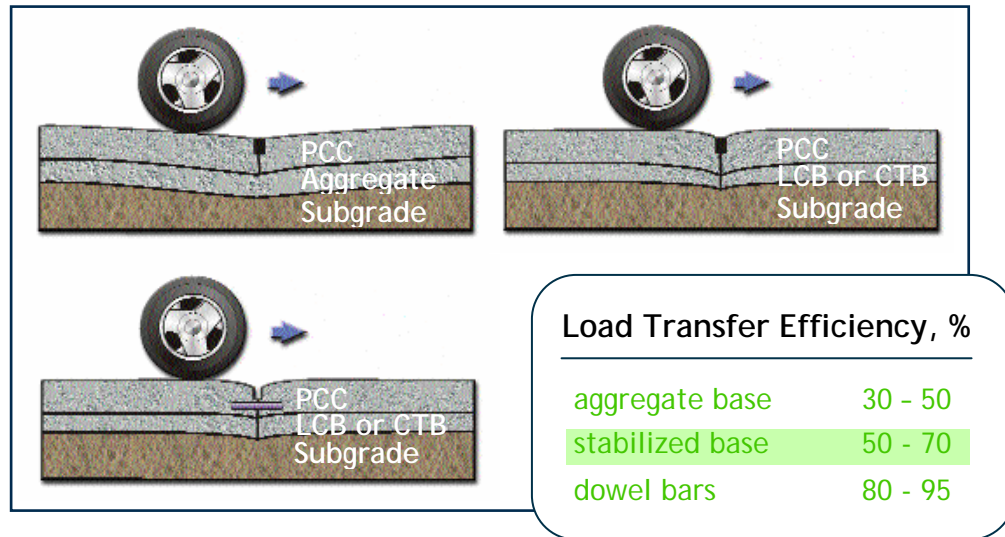
LOAD TRANSFER

Caltrans' concrete pavements typically rely on aggregate interlock and the treated base course for load transfer. The coarse aggregate in the PCC at the slab joint faces interlock to help transfer wheel loads from one slab to the next. The bottom figure on the opposite page shows a good example of aggregate interlock. Over time, the exposed surface of coarse aggregate may become worn due to repeated loadings and weathering, resulting in a smoother texture and a lower load transfer capacity. This reduction in load transfer capacity leads to increased joint movements and an increase in pavement distresses.

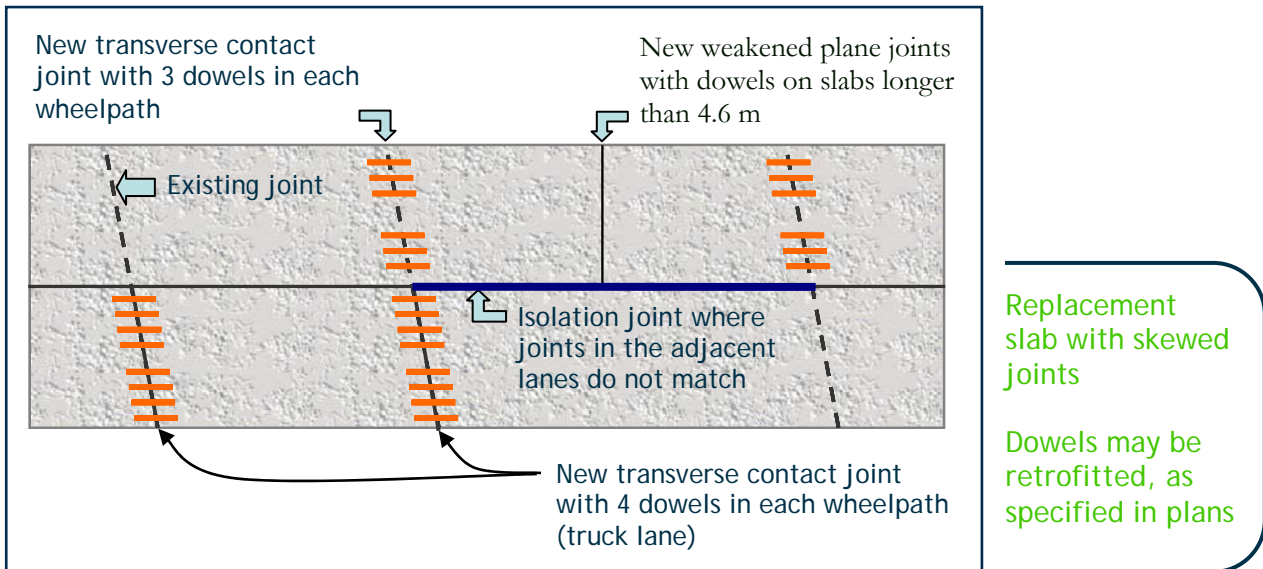
The illustration below is for instructional purposes only, where dowels are placed either by drill-and-bond method or retrofitted.

Special Case Illustration: use when placing dowels

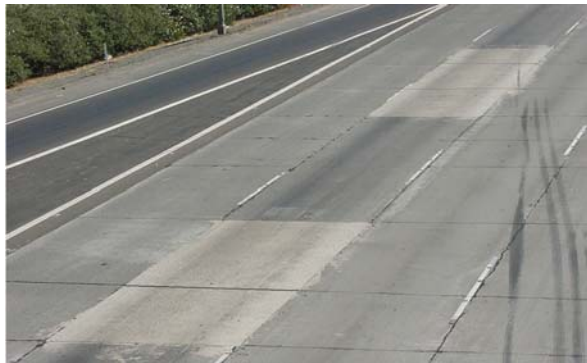
An example of two closely located repairs with existing slabs in between. A more cost-effective option may be to place one continuous repair with weakened plane joints.

Note: When two repairs are closer than the distances shown in the table, they should be combined into one large repair.

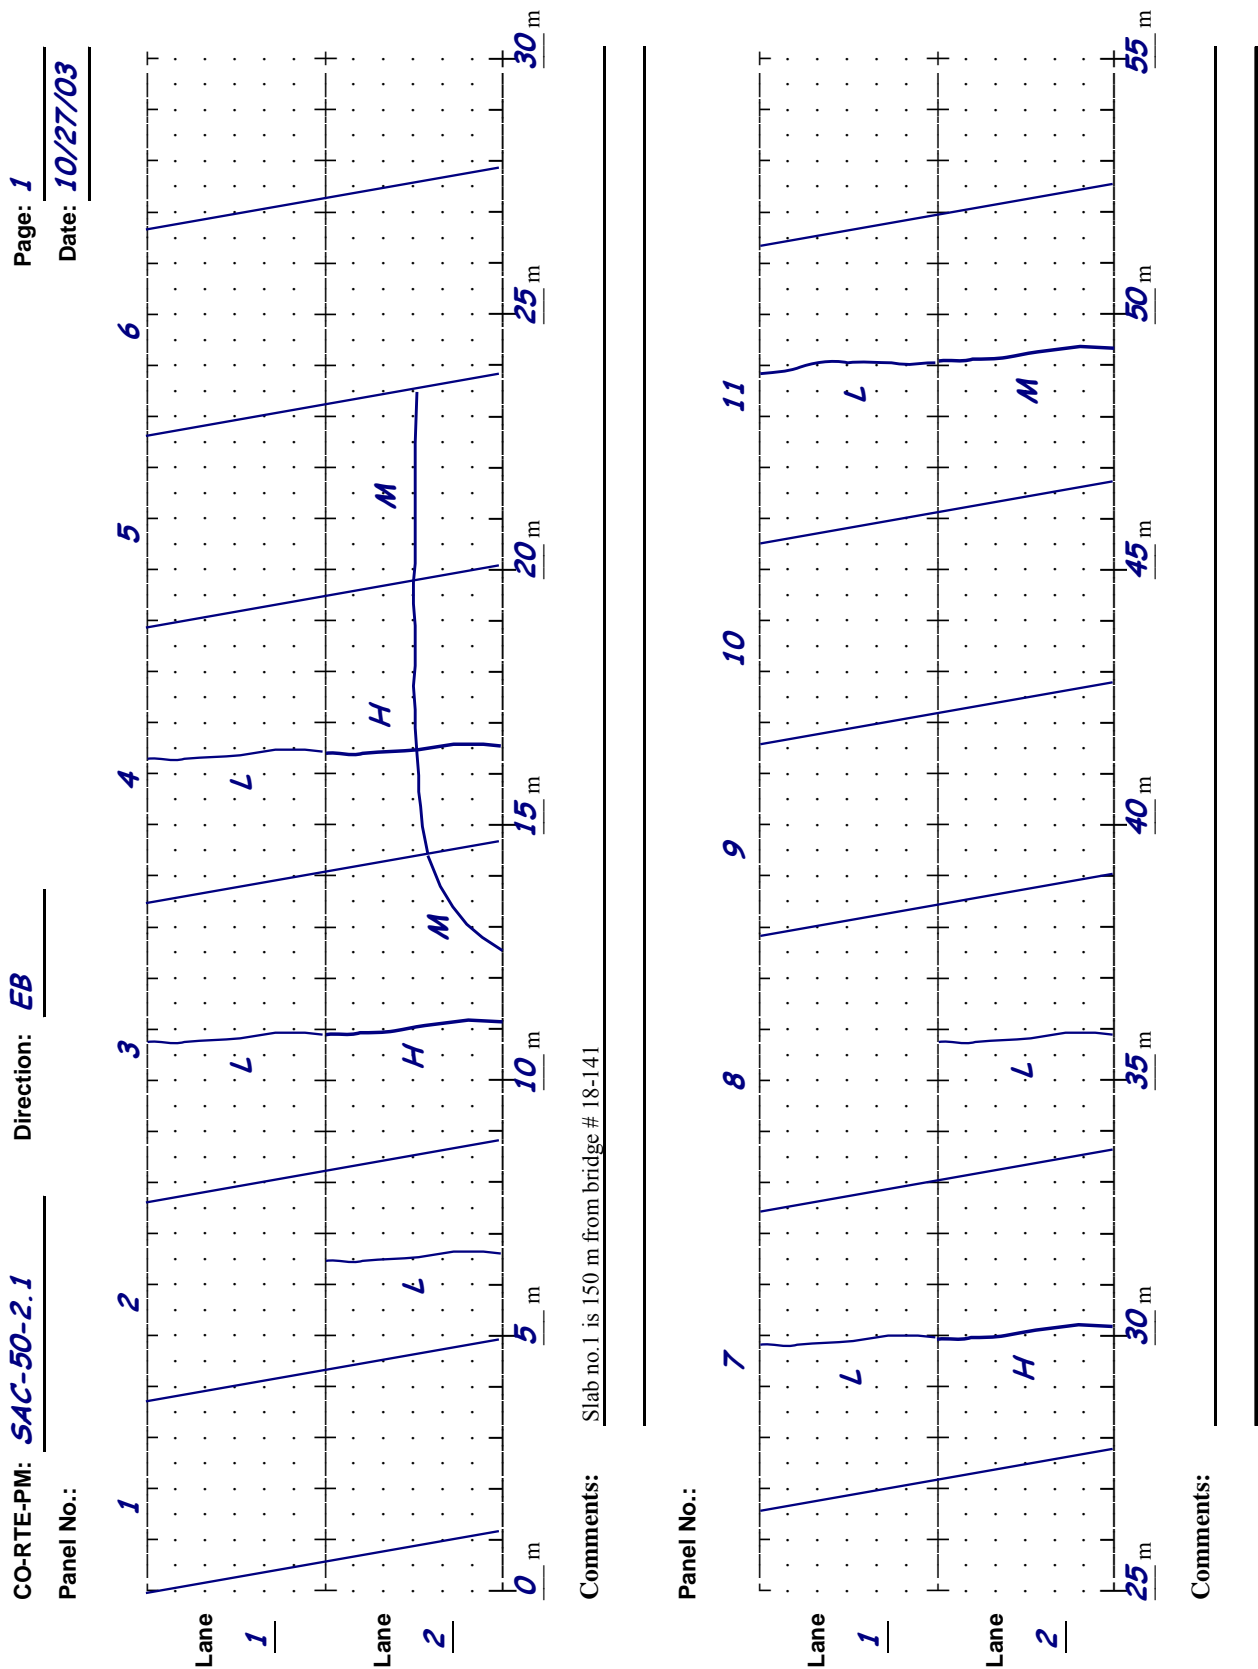
EXAMPLE DISTRESS MAP (SEE APPENDIX A)
